PHOTOGRAPHIC INTERPRETATION REPORT

SOVIET MILITARY ORDER OF BATTLE ODESSA MD

BALTA ARMY BARRACKS

BALTA, ODESSKAYA OBLAST, USSR

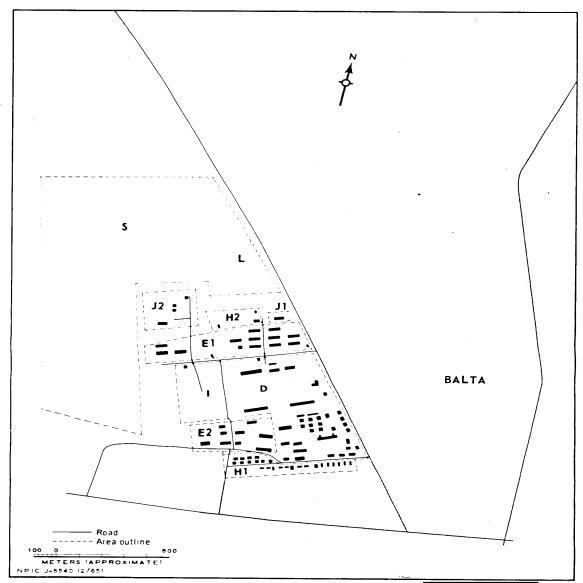
FIGURE 3. BALTA ARMY BARRACKS. Sketch compiled from Mission

Area D contains 2 administration buildings, 5 barracks, 4 storage buildings, and 29 support buildings. Ten of the support buildings were constructed between

Area F1 contains 12 storage buildings and 3 support buildings.

Area E2 contains 5 storage buildings and 4 support buildings.

Area $\overline{H1}$ contains $\overline{25}$ quarters dependents bossing units.

Area H2 contains 3 support buildings. Two

Area J1 contains a possible vehicle storage 'maintenance building, 200 by 90 feet.

Area J2 contains a possible vehicle storage maintenance building, 150 by 50 feet, and 3 support buildings.

Area L is a small-arms firing range, 400 by 50 feet. This range appears to be active.

Area S contains an SA-2 site, possibly for training purposes. This site was first observed in and it appears abandoned on photography of
